SAECO INTERNATIONAL GROUP  
Via Torretta 240  
40041 Gaggio Montano (BO)  
Italy  
Telephone: +39 0534 770511

Date / Data: 10/05/2011

Information Nr: 09/11

## Subject: Low milk temperature in Xelsis, Exprelia and Gaggia Accademia

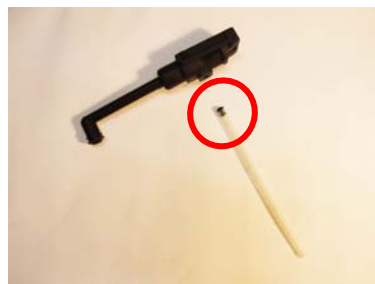
Image 3

Complaint of low temperature of milk beverages in Xelsis, Exprelia and Gaggia Accademia. Modification implemented in production in week 09 / 2011

Replace the black milk tube connector by the white one, part code 11026779, in order to increase the milk temperature by 2-4 degrees.

Replace the connector shown in the image 3.

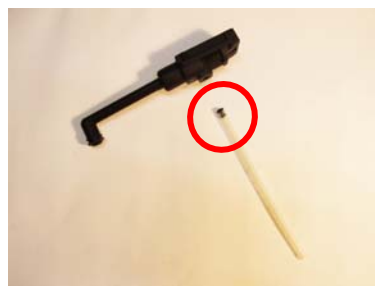
Immagine 3

Prodotti latte non a temperatura ottimale.

Per aumentare mediamente di 2-4 gradi la temperatura del latte emulsionato, sostituite il raccordo esistente (colore nero) con il nuovo raccordo (colore bianco) codice 11026779.

Sostituire il raccordo tubo aspirazione latte evidenziato (immagine 3)
