# Instruction

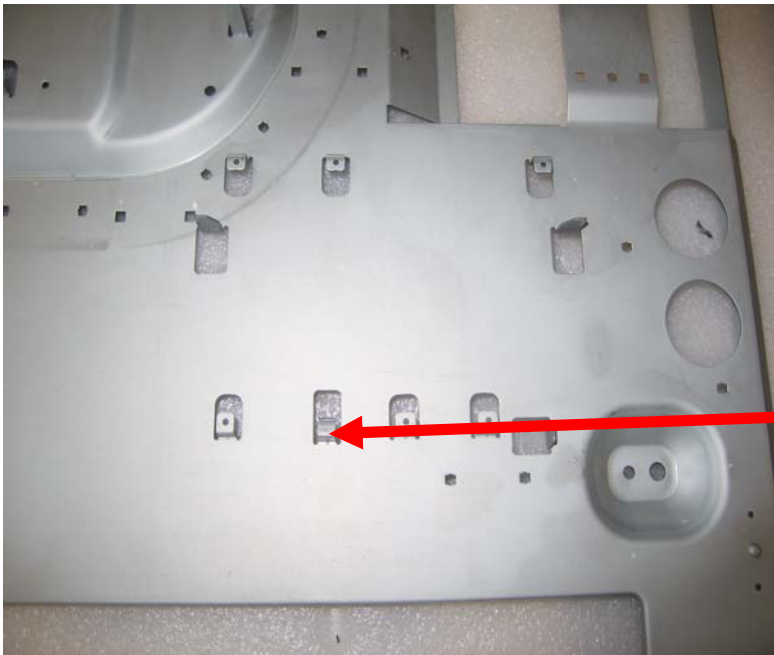
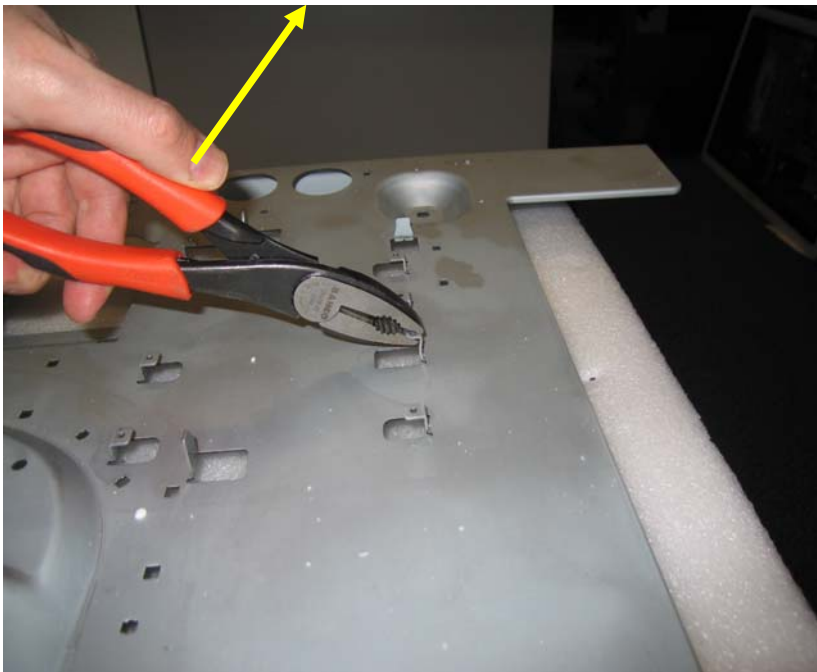
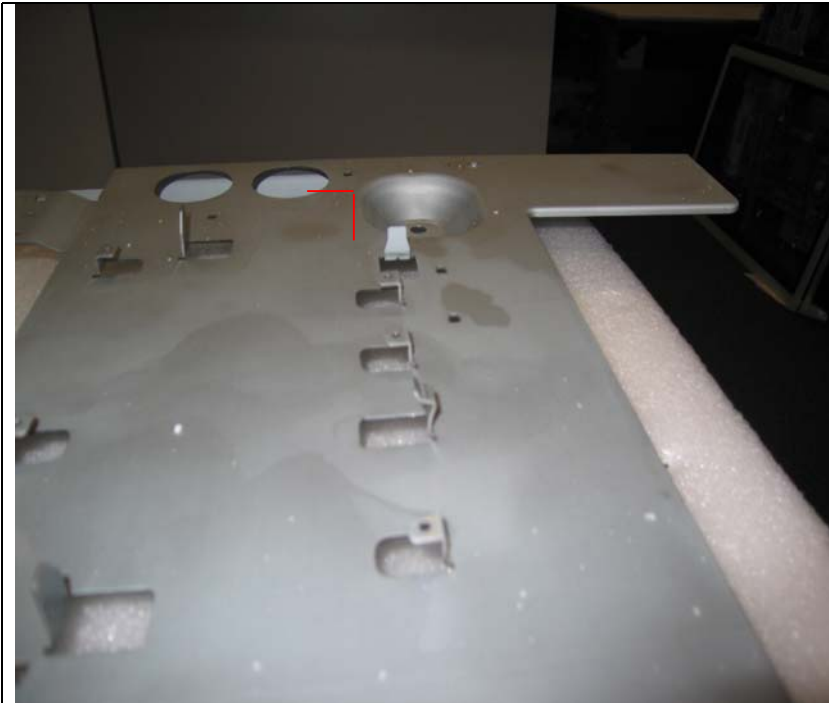
Reason: The DFI panel is bent under pressure of this lip.

Bend this lip  
over (min 1 mm)

Tools: Combination Pliers
